## Wastewater Treatment System (WTS) Performance Evaluation & Capacity Assessment

| Project Overview | |
|---|---|
| <b>Property address:</b> | 3588 Wallace Point Road, Peterborough, ON |
| <b>Date completed:</b> | July 13, 2026 |

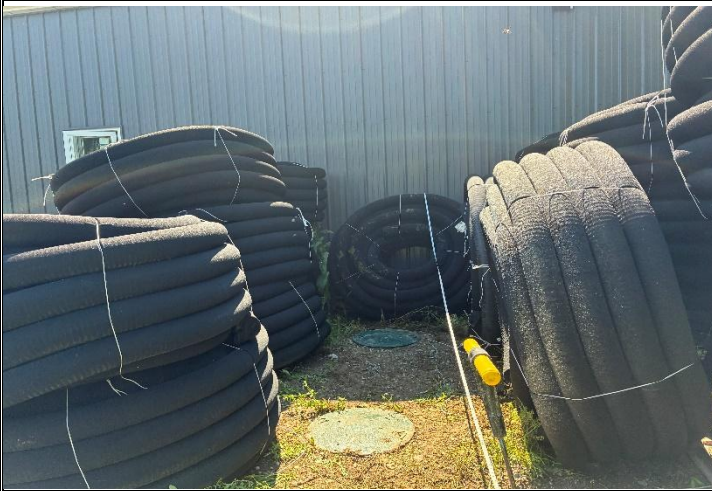
1. Septic tank location

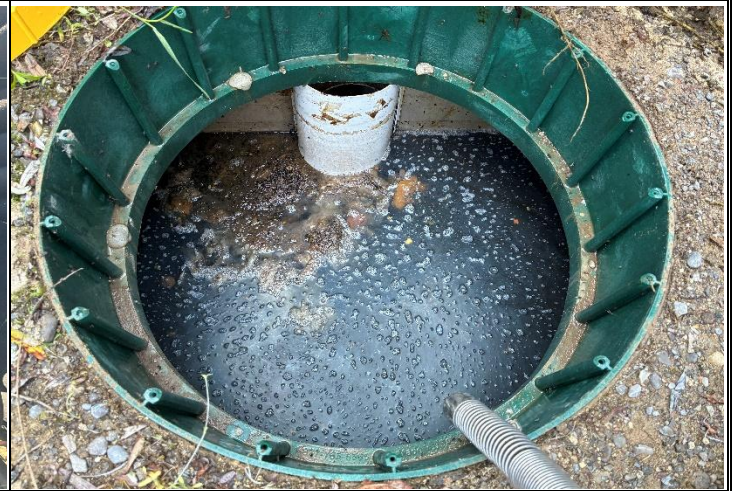
2. Septic tank inlet compartment

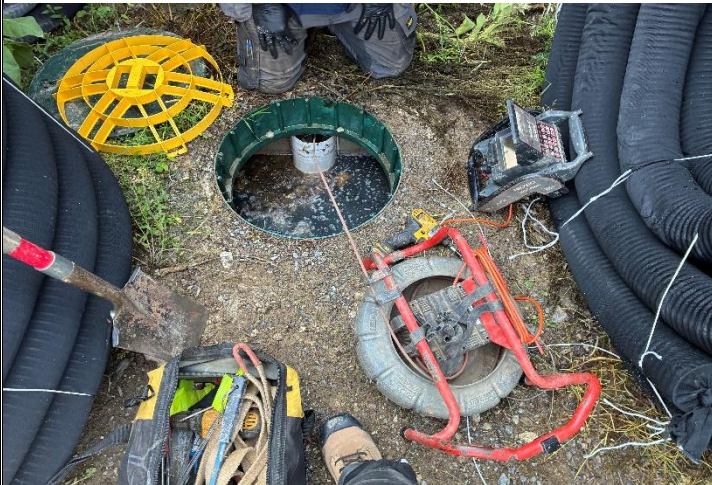
3. Camera inspection of sewer line

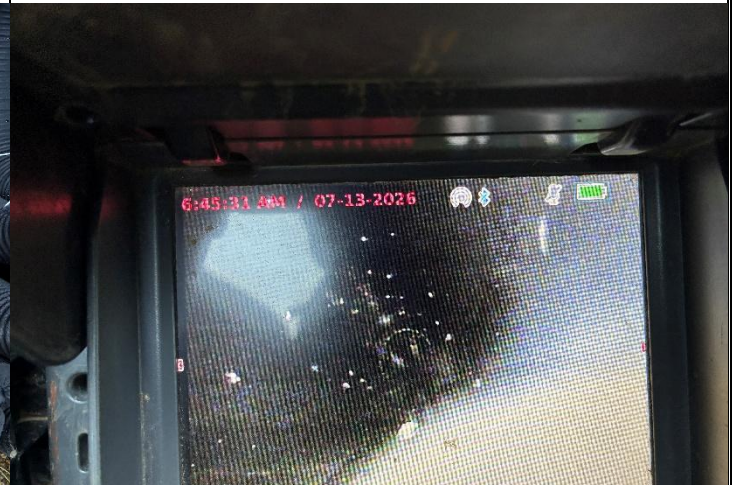
4. Interior of sewer line

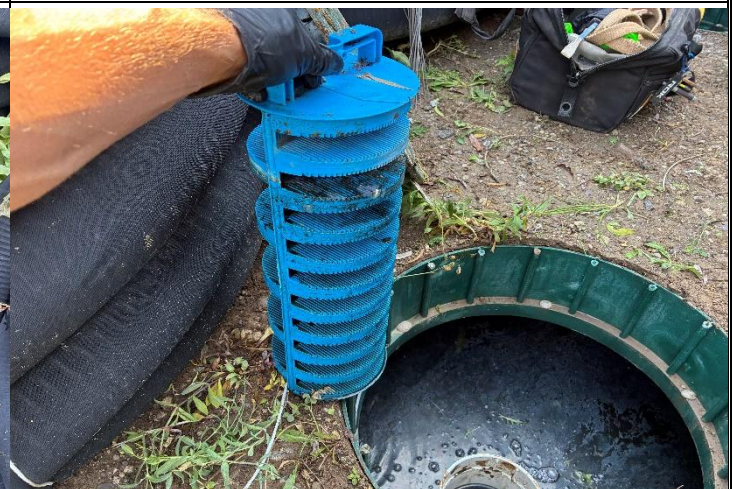
| Criteria | Status | Notes |
|---|---|---|
| Condition of Outlet Baffle | Functional | Effluent filter installed within outlet compartment of tank (removed and cleaned during inspection) |

6. Effluent filter installed in outlet compartment of tank – removed and cleaned during inspection

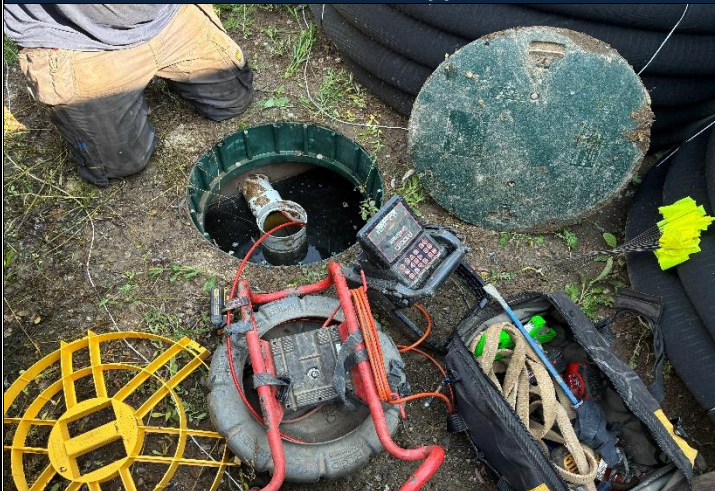
7. Camera inspection of discharge line – leading from septic tank to leaching field

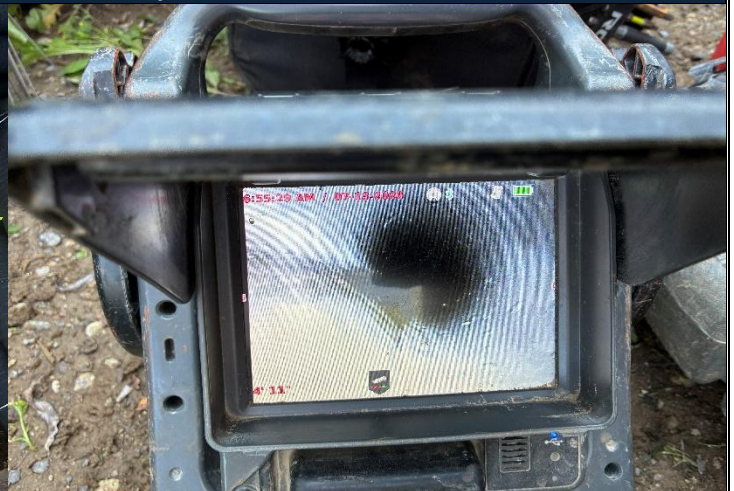
8. Interior of discharge line

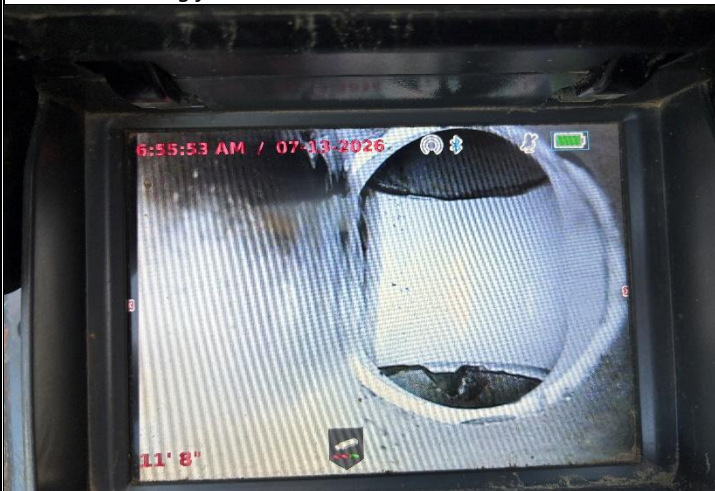
9. Interior of discharge line – header manifold visible

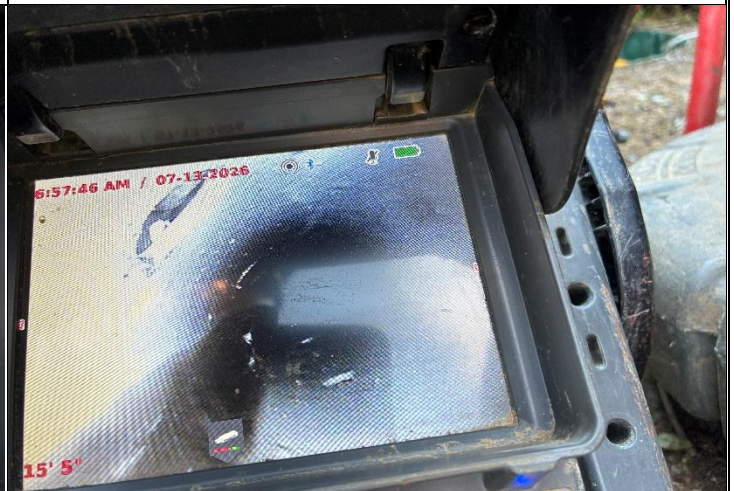
10. Interior of perforated distribution lateral

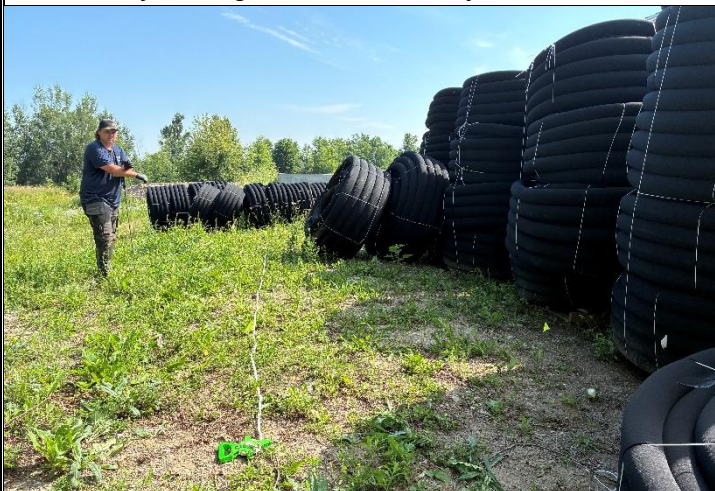
11. Location of sand filter bed surface

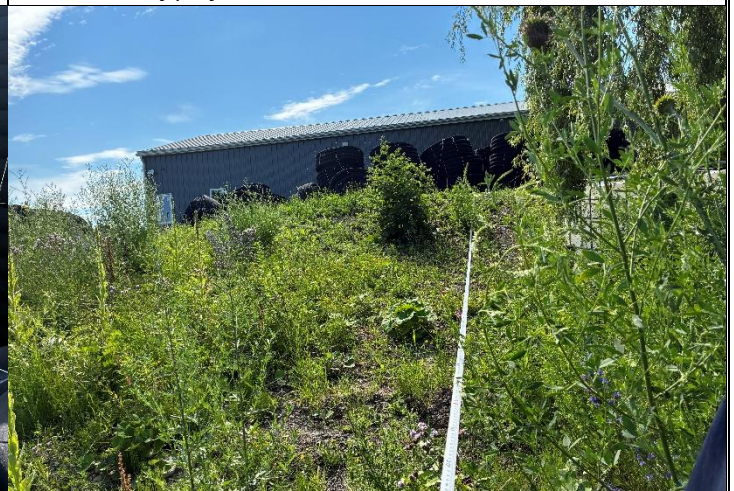
12. Extent of sand filter bed

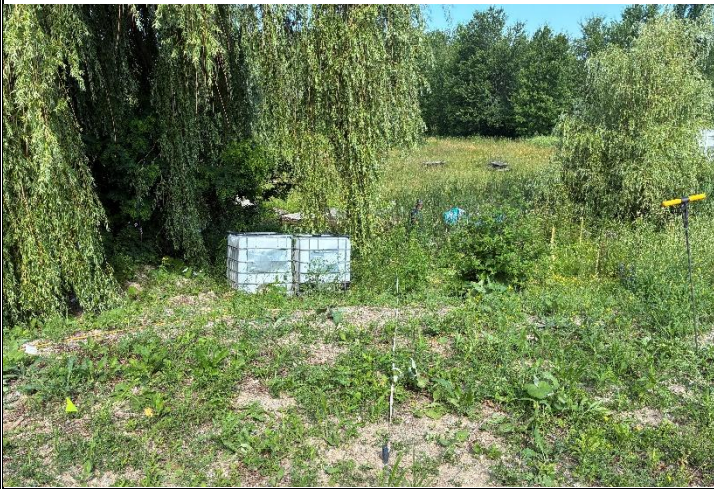
13. Extent of sand filter bed

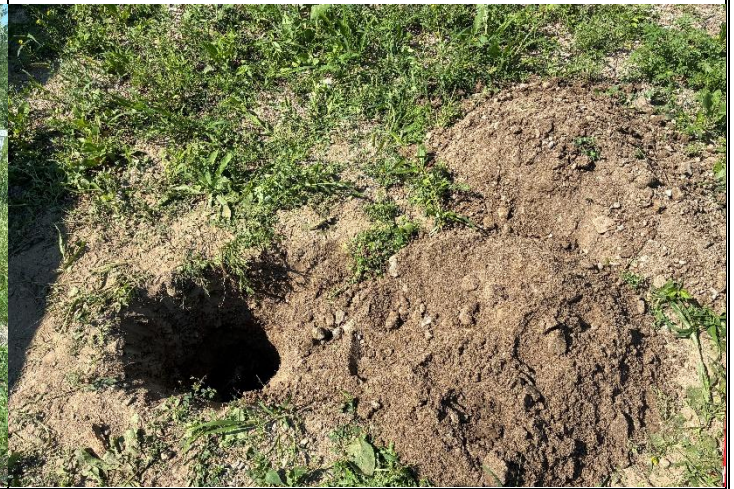
14. Test hole 1 excavated for collection of filter base material

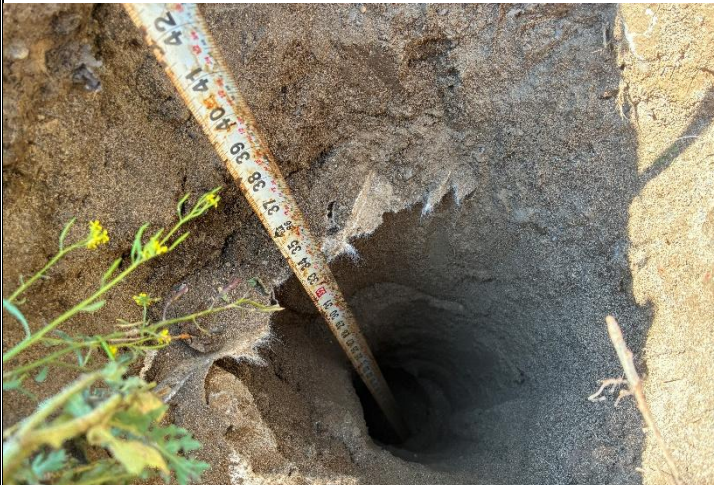
15. Interior of test hole 1. No water observed and geotextile covering washed stone visible

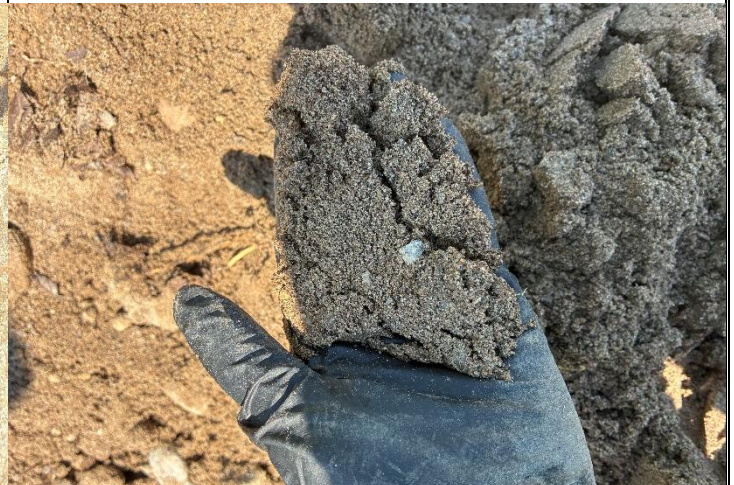
16. Soil collected from sand filter base

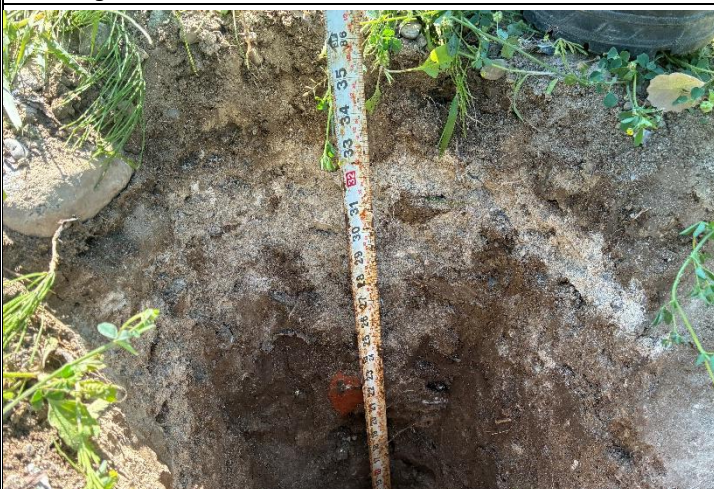
17. Test hole 2 excavated for inspection of mantle material and collection of native soil

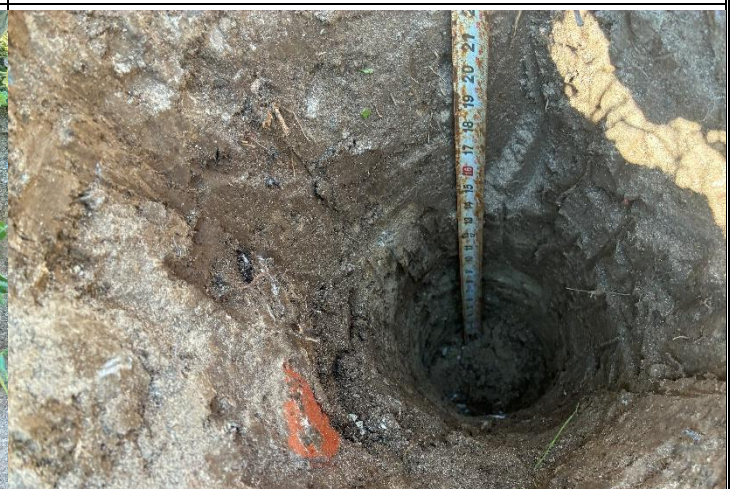
18. Base of test hole 2. No ground water observed.

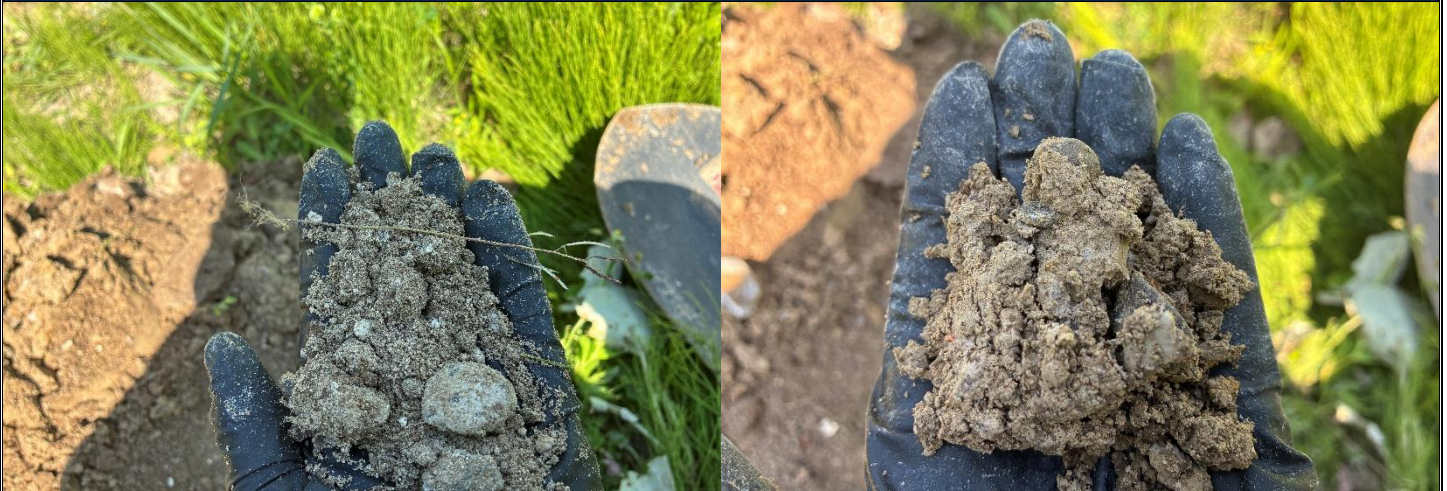
19. Mantel consists of sandy soil – not submitted for analysis

20. Native soil collected

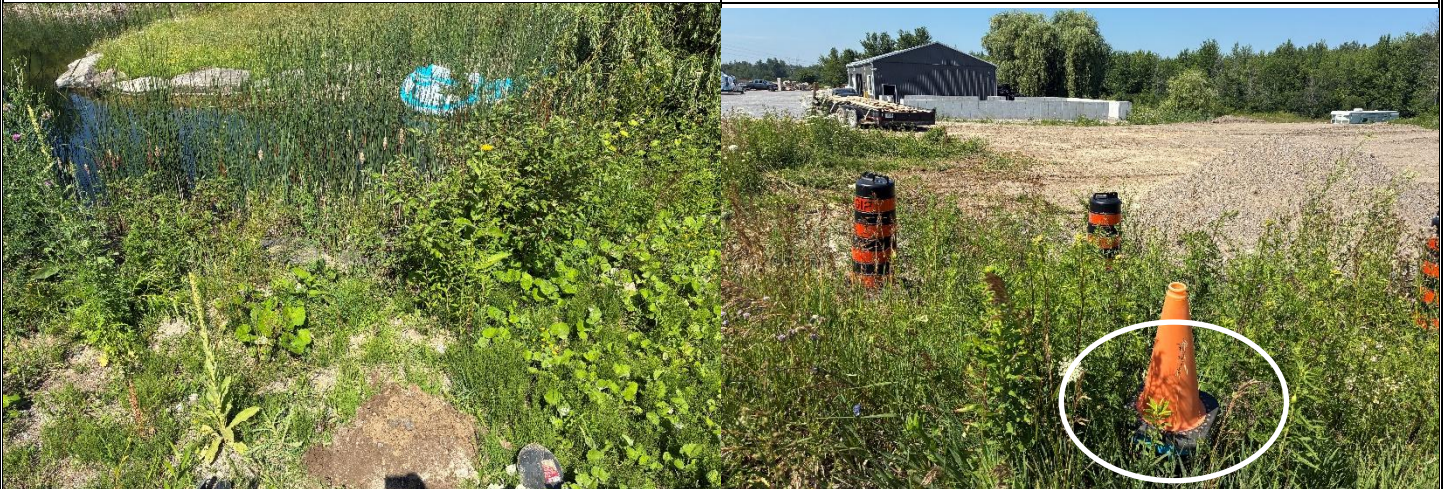
21. Location of test hole 2 located at the end of the sand filter bed mantle

22. Drilled well location

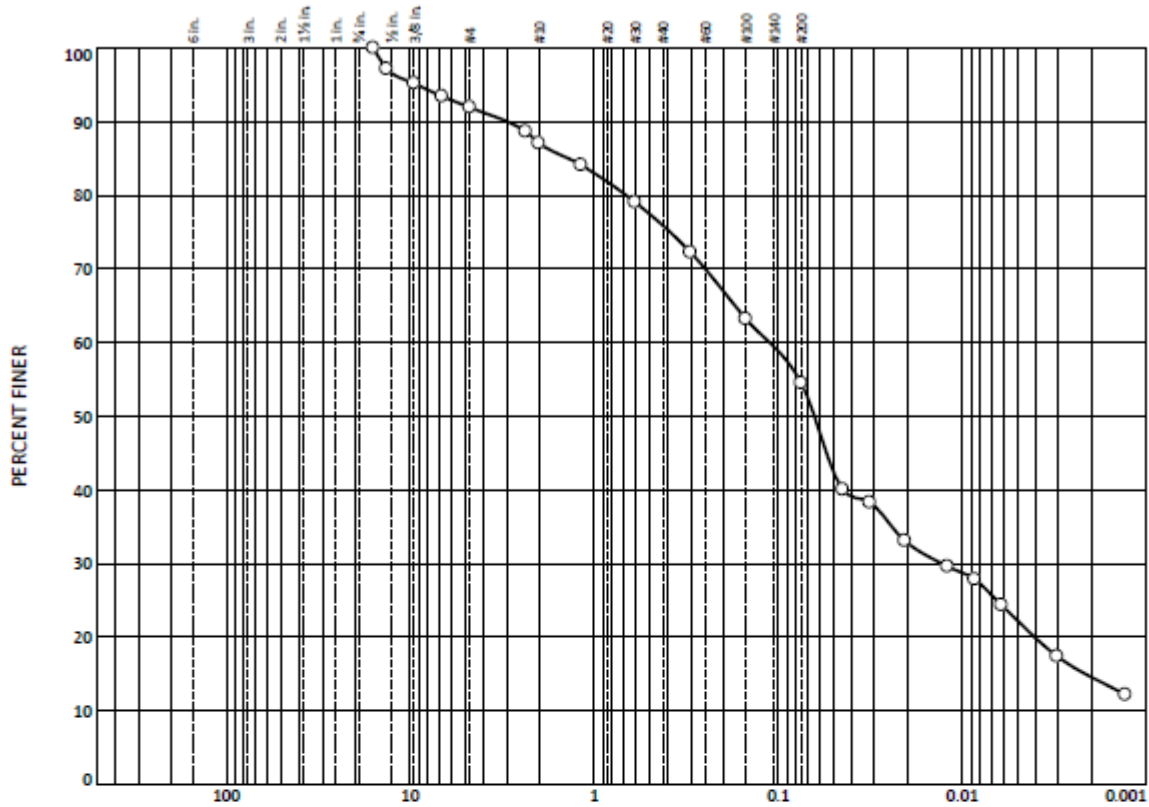
Figure 1

| | SOURCE | SAMPLE NO. | DEPTH (ft.) | Material Description | USCS |
|---|---|---|---|---|---|
| ○ | Client | 1 | | Native - 3588 Wallace Point Road, Peterborough, Ontario | ML |
| | | | | silt and sand, some clay, trace gravel | |
| | | | | Estimated Percolation Rate; T = 30 min/cm | |

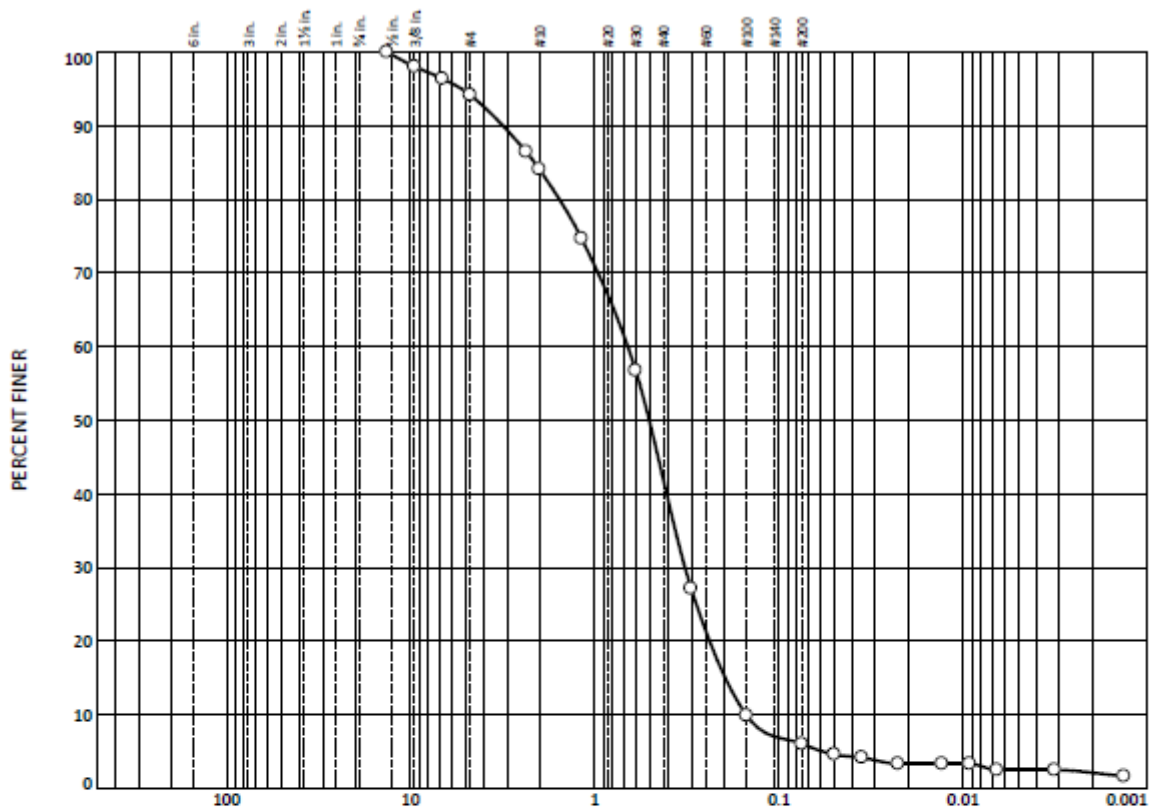
Figure 2

| SOIL DATA | | | | | |
|---|---|---|---|---|---|
| ○ | Client | 2 | | Fill - 3588 Wallace Point Road, Peterborough, Ontario | SP-SM |
| | | | | sand, trace gravel, silt, and clay | |
| | | | | Estimated Percolation Rate; T = 10 min/cm | |
