EslerSports Complex Access Project  
Geometric Design  
0+000.000m TO 1+173.000m

| CRP: Darron Campbell, Manager of Community Services | DWG#: 134-007-001 |

## ROAD DESIGN STANDARDS

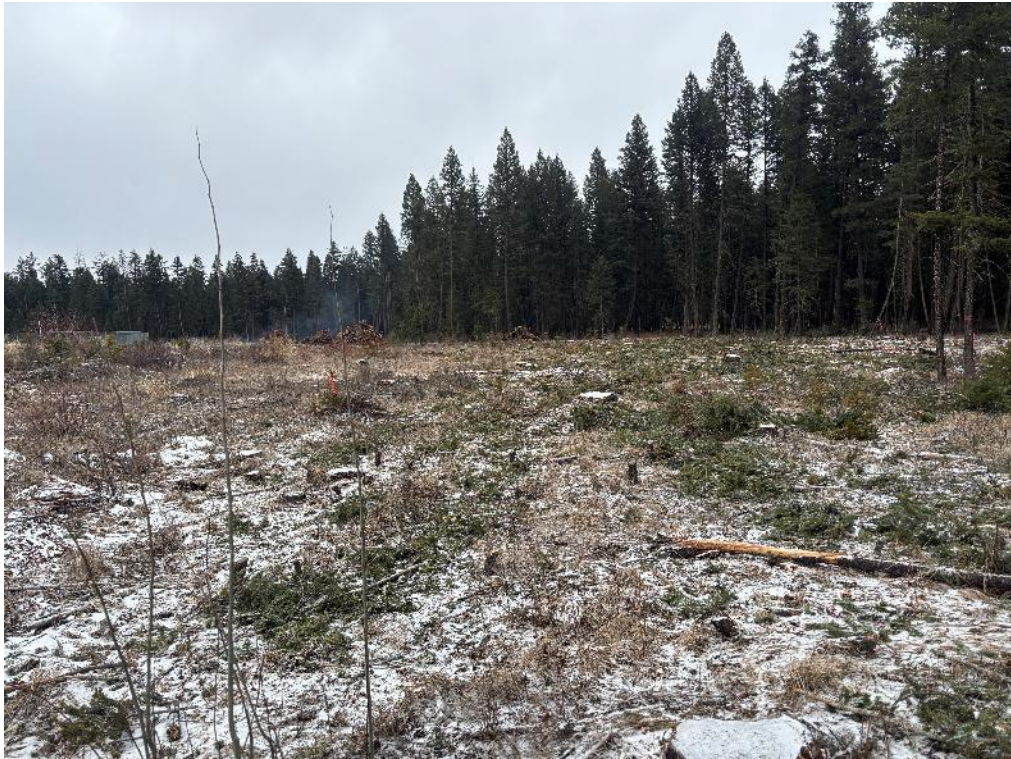
**Photograph 1.** Part of the already cleared area for the loop road around the baseball fields.

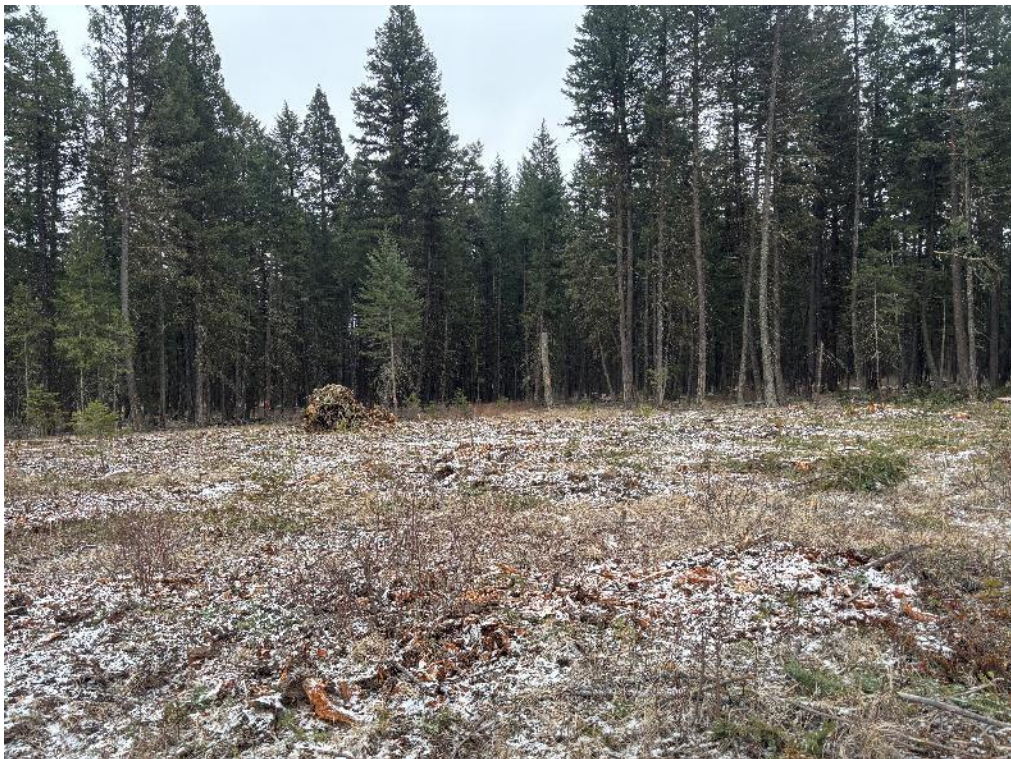
**Photograph 2.** Already cleared area and typical stand type in the vicinity of the Project.

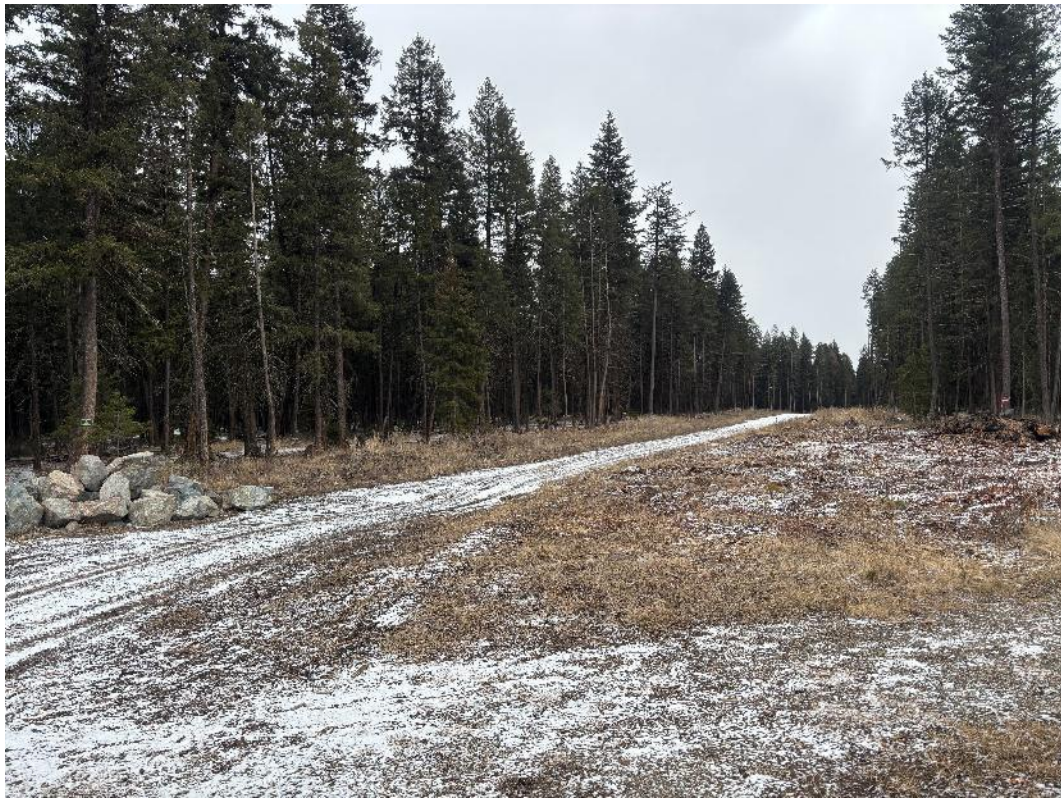
**Photograph 3.** Existing gravel road and cleared right of way that is part of the new access road to Highway 20.

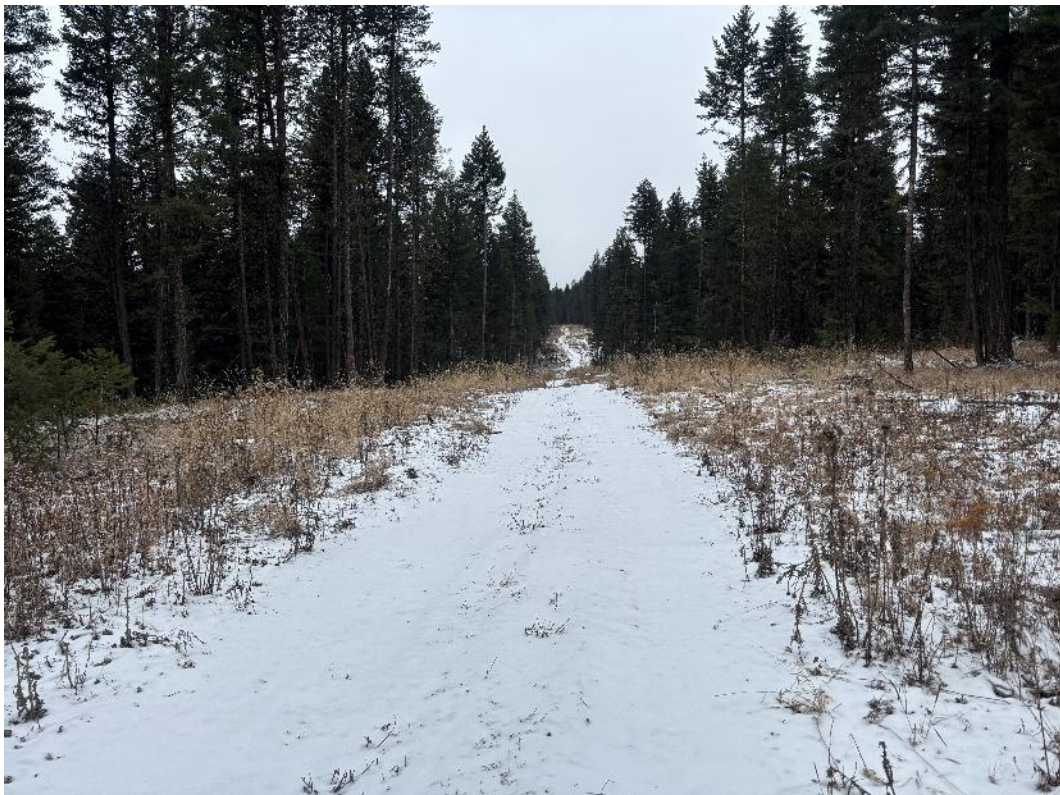
**Photograph 4.** Middle portion of the new access road to Highway 20 with majority of right of way already cleared.

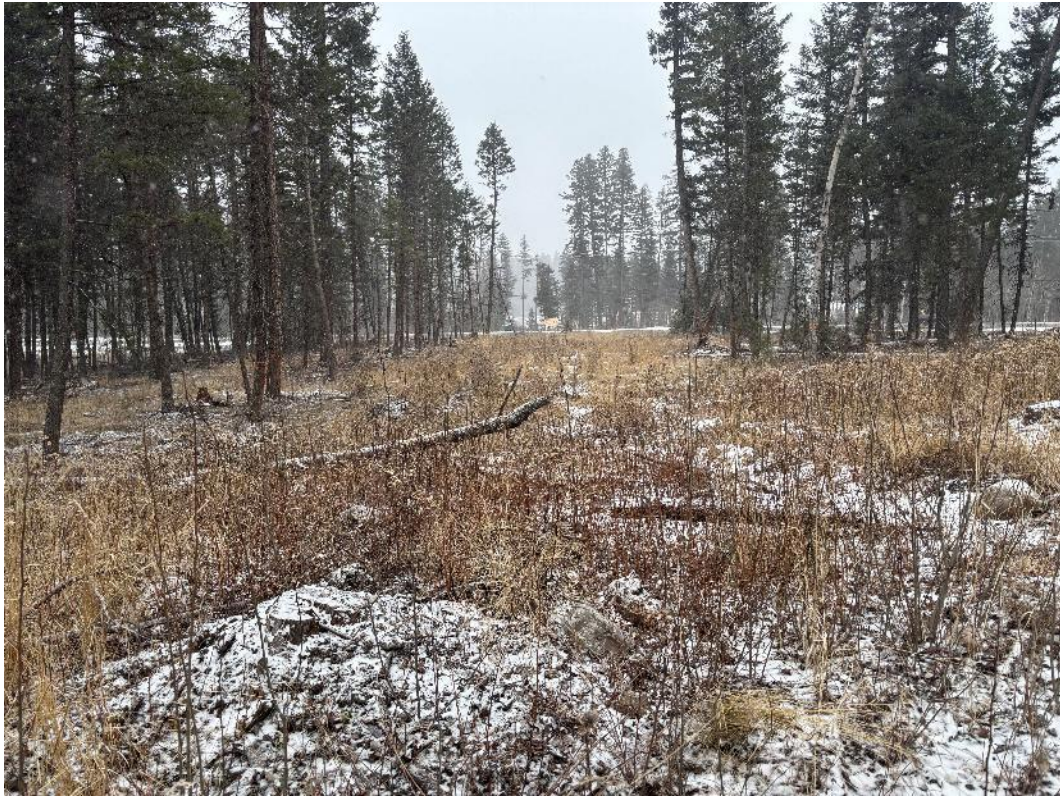
**Photograph 5.** Final portion of new access road looking at future junction with Highway 20.

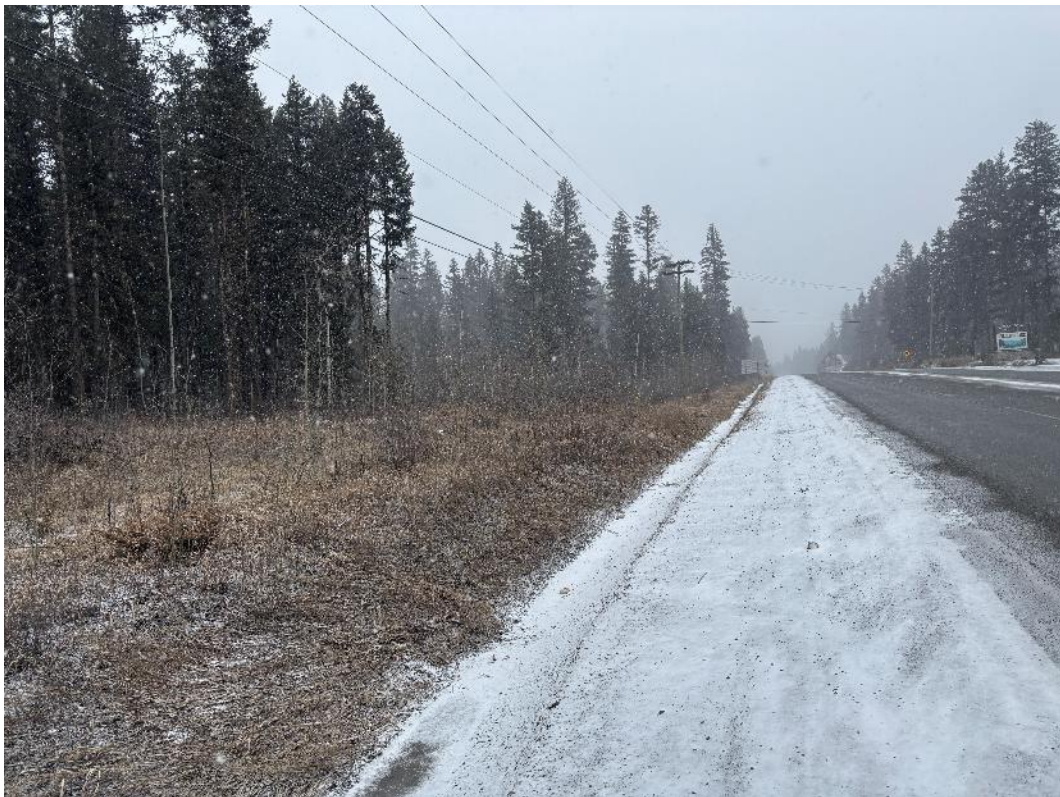
**Photograph 6.** New access road at junction with Highway 20, looking south towards Williams Lake.

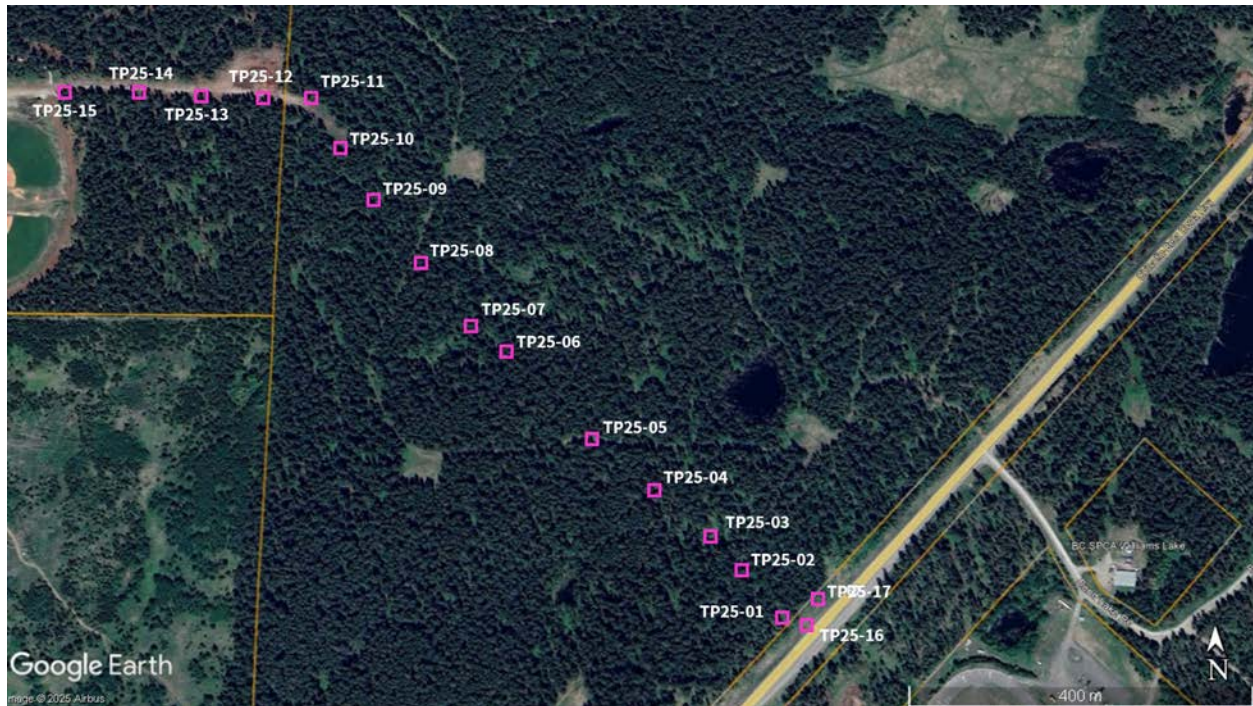
Figure 1. The proposed road alignment and test pit locations shown on Google Earth Imagery 2023.
