# **Hydrogeological Report**

**1812 County Road 10,  
Village of Ida, Township of Cavan-  
Monaghan, Ontario**

**Project: 0007-001**

**January 8, 2026**

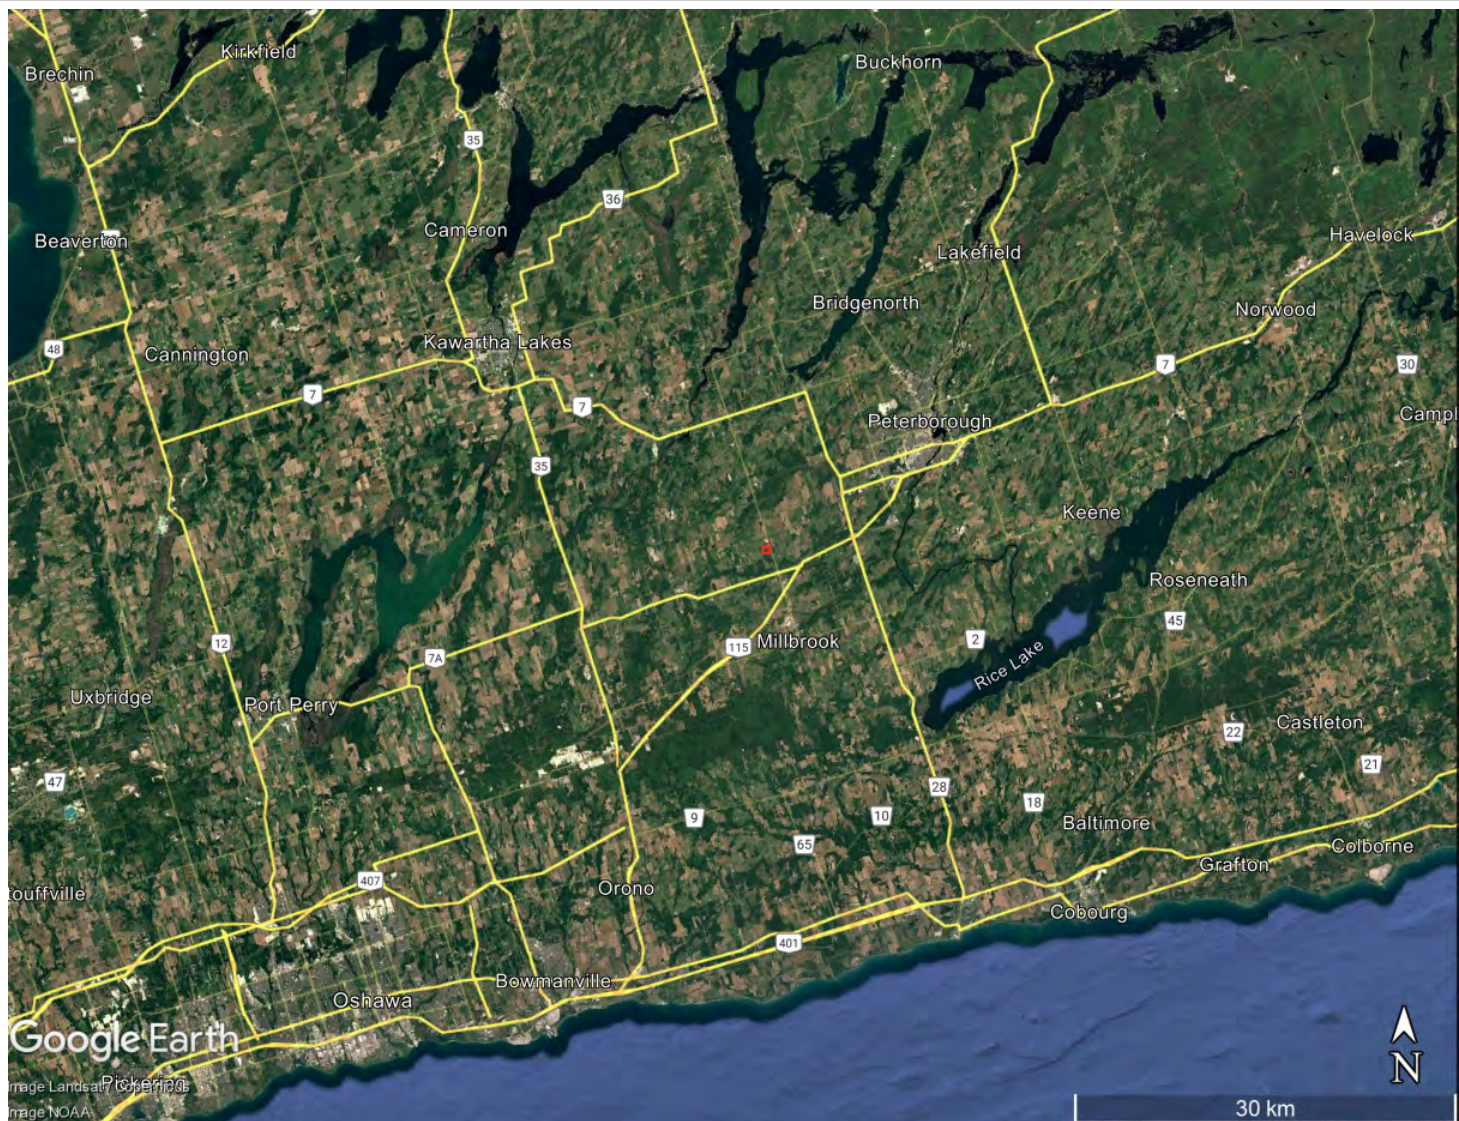
## **Figure 1**

### **Regional Location Plan**

Site: 1812 Peterborough County Rd.  
10, Village of Ida

Pigeonview Consulting Inc. (PV) was retained by Ian Cameron (the Client) to evaluate the hydrogeological conditions for the proposed development located at 1812 County Road 10, Village of Ida Township of Cavan-Monaghan, Ontario (the Site). The regional location of the Site is illustrated in **Figure 1**.

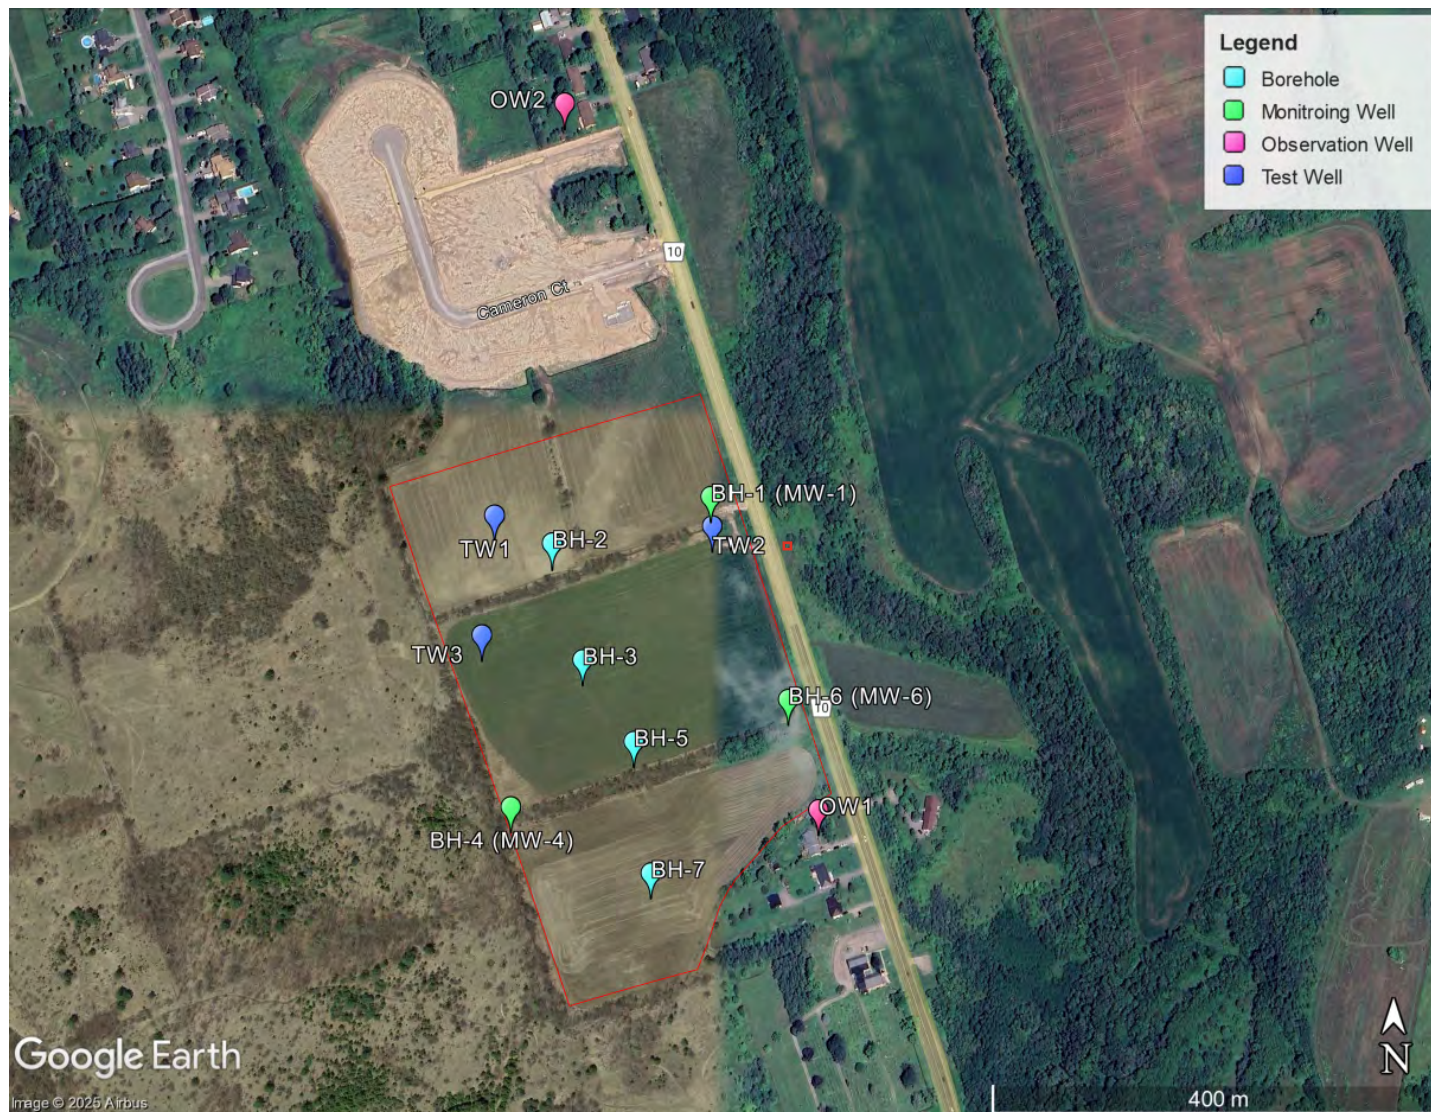
**Figure 2**  
**Detailed Site Plan**

The boreholes completed by Redstone Engineering were used to evaluate the subsurface soil conditions at the Site. Details of the borehole advancement are summarized below in **Table 4.2A**, their locations are presented in **Figure 2**, and their corresponding borehole logs are provided in **Appendix B**.
