Phase One Environmental Site Assessment

Proposed Residential Development, 9380 Burwash Road, Baltimore, Ontario

Stalwood Homes

19 July 2024

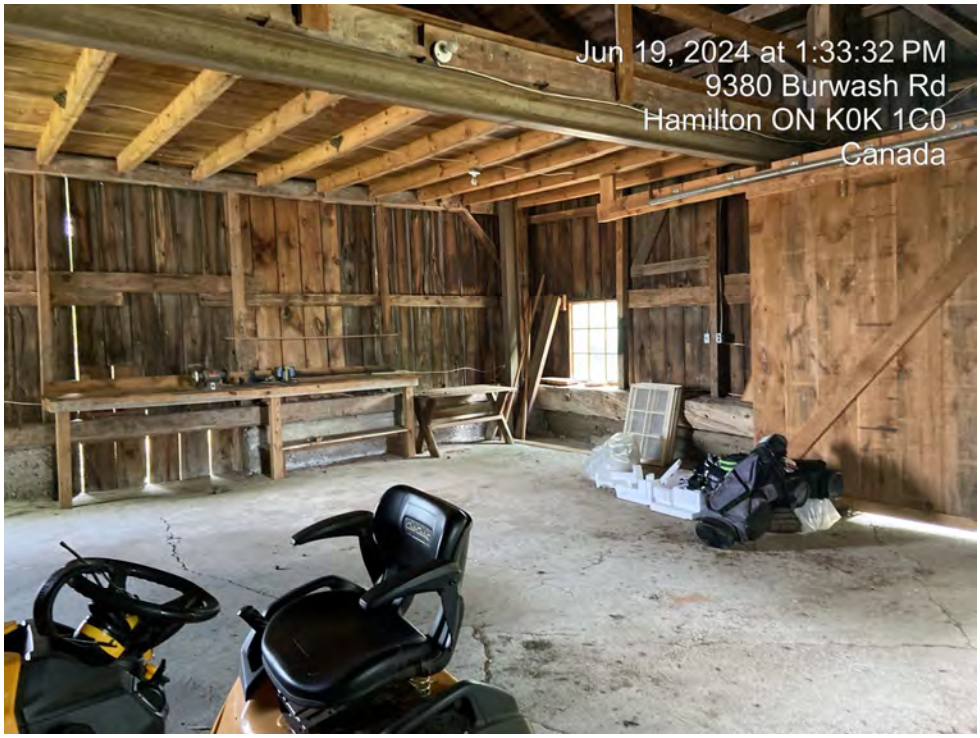
Photo 7 - Looking southerly at the east end of the barn.

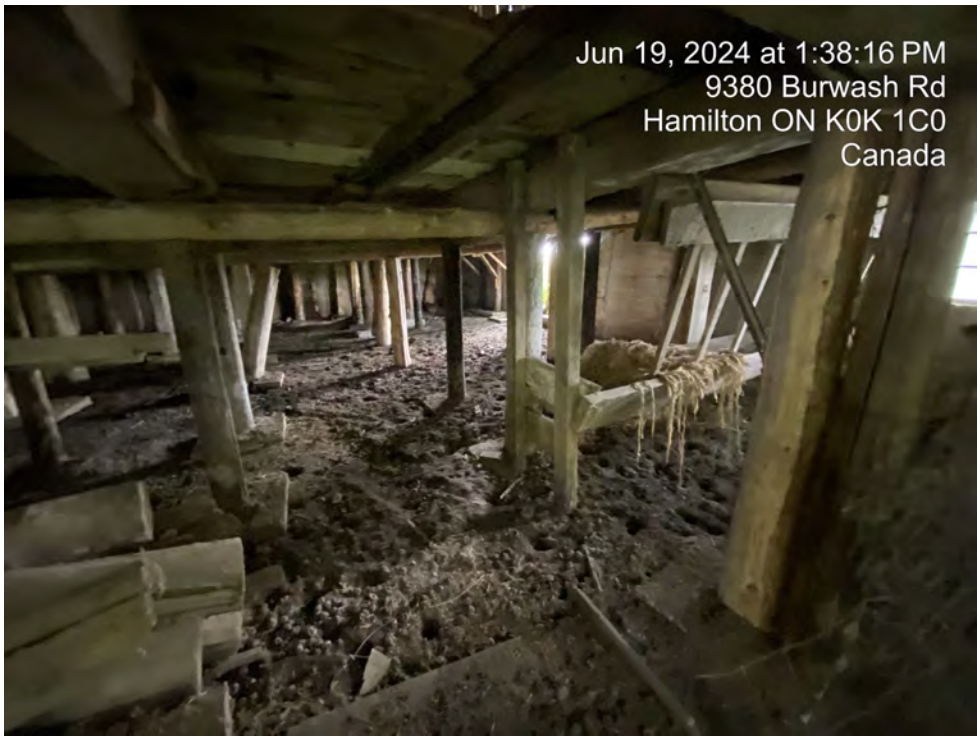
Photo 8 - Looking northerly along the first floor of the barn interior east end.
